Concrete Growth and Fatigue Analysis of Chickamauga Lock Miter Gate Anchorages

Final report

Under Project 111274, "Structural Analysis of Chickamauga Lock Gate Anchor Rods"

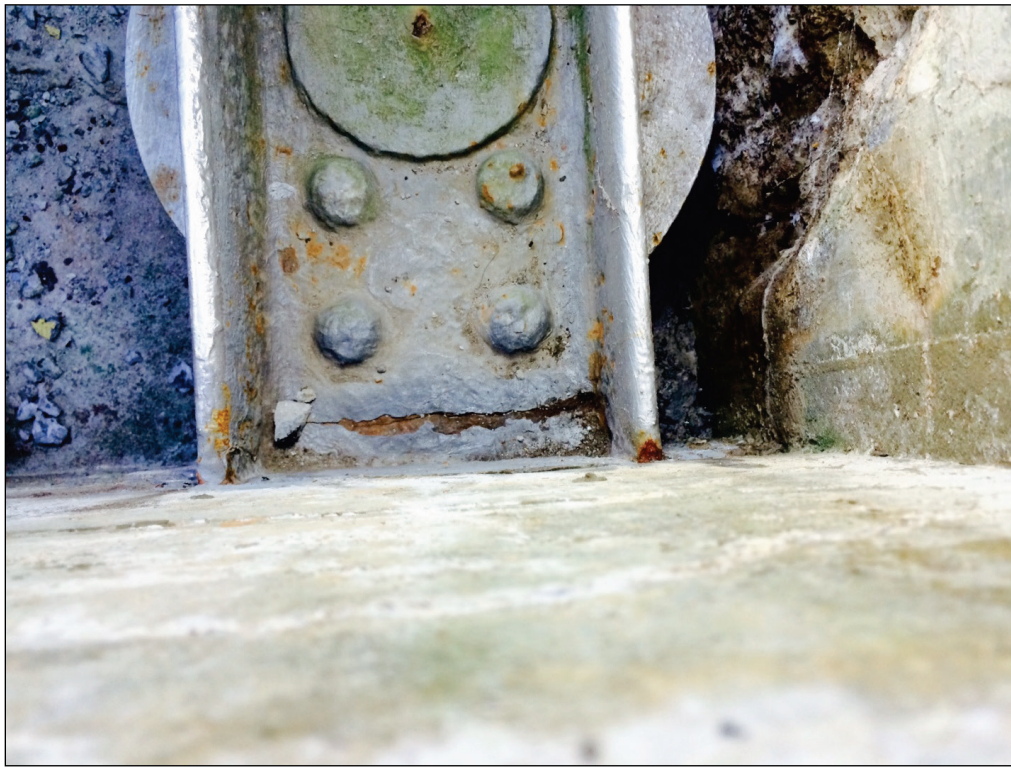
During routine lock maintenance on 27 October 2014, extensive concrete cracks in the area of the miter gate anchorage for Monolith 22 were noticed. The maintenance engineer who noticed the concrete cracks contacted LRN engineers to further inspect the cracks. During an examination of the cracks in the concrete, LRN and Chickamauga Lock personnel decided to also examine the opposing miter gate monolith, Monolith 37, to compare with the cracks found in the concrete on Monolith 22. During this inspection, a large crack (shown in Figure 6 and Figure 7) in the web of the top steel channel of the miter anchorage at Monolith 37 (river side of lock) was found. Immediate operation of the lock was postponed, and a repair plan by the LRN and TVA was soon drafted. For the next 8 days, USACE and TVA personnel repaired the channel.

Figure 6. Top view of embedded miter gate anchorage crack observed in October 2014.

The repair strategy started with the removal of all anchor pins and gudgeon linkages for the miter and recess anchors. Next, the doubler plate on the upper embedded miter anchor channel was removed to repair the crack, cutting a 1.25 in. wide slot in the damaged channel web around the crack with a torch. A replacement doubler plate was then installed by welding the new doubler plate to the anchor channel in the old rivet locations and sides of the plate to the side of the channel (Figure 8). Next, the slot where the crack was removed was welded and nondestructively tested to ensure a good weldment was present. New pins were fabricated and placed in new line-bored holes on both miter and recess gudgeon linkages. Several adjustments of the miter linkage were made to have a final resting quoin clearance of 0.027 in. at the top. During the adjustment phase after the repair, the gate remained at the same elevation with each gate cycle.

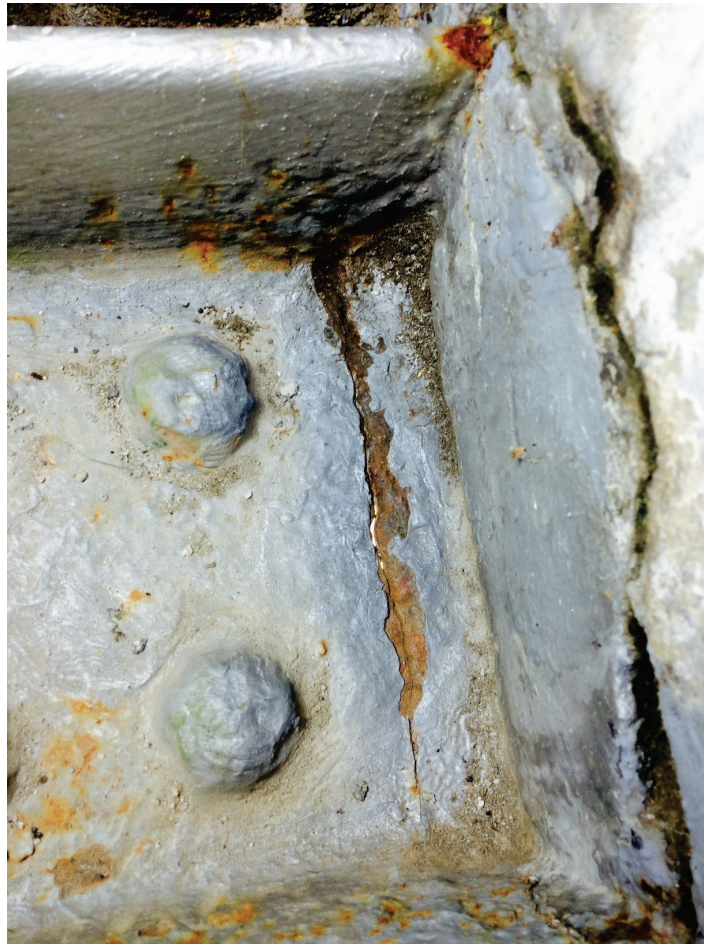
Figure 7. Close-up view of embedded west miter anchorage crack observed in October 2014.

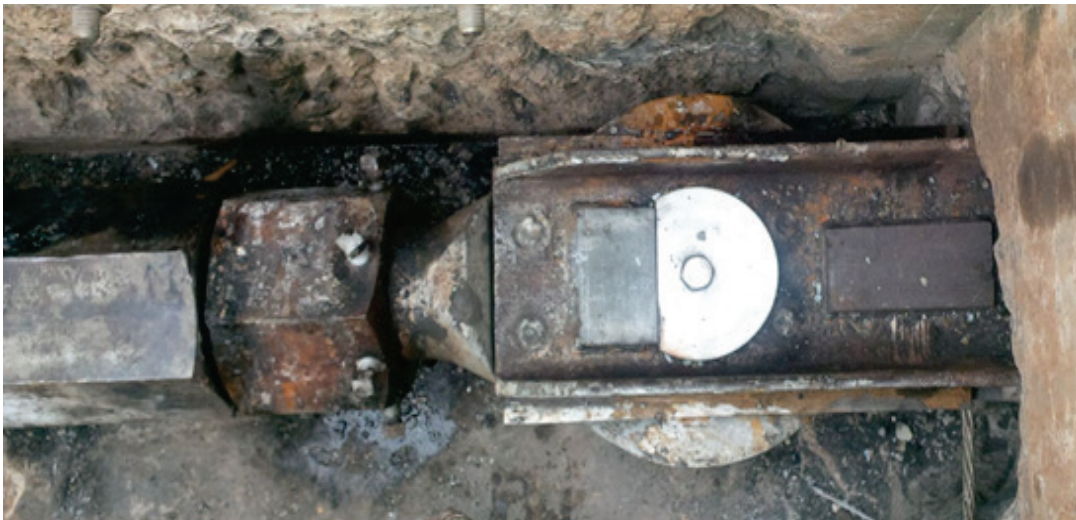
Figure 8. Repaired riverside miter anchorage channel.

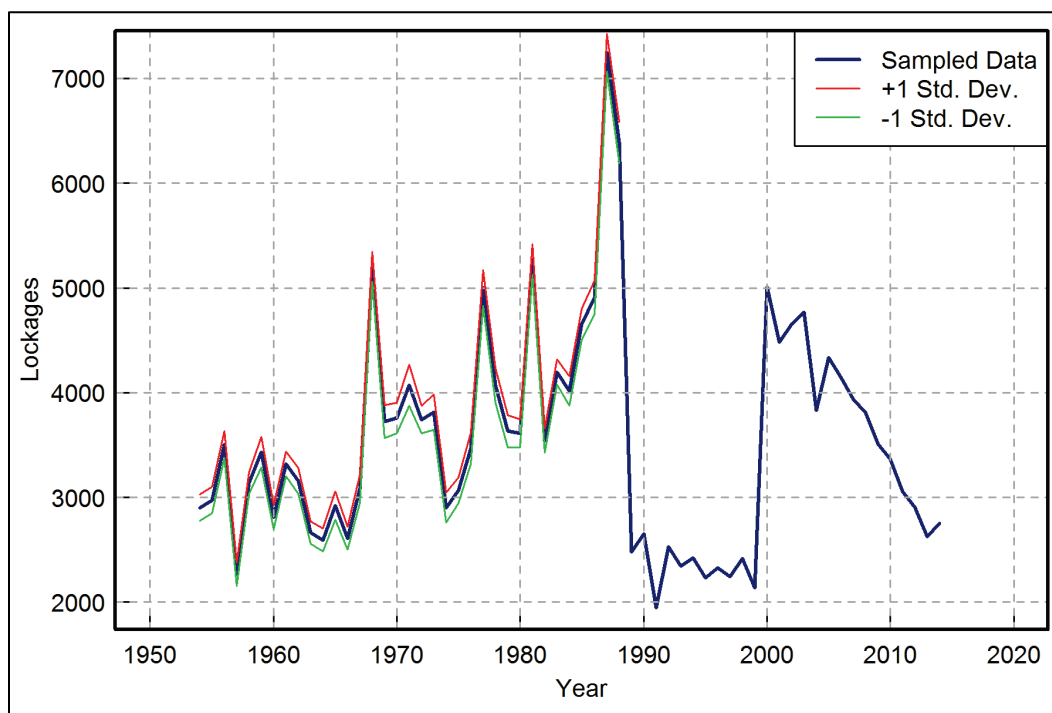
Figure 9. Chickamauga lockage history data.

There was uncertainty about whether the paper logs recorded counts of lockage cycles or number of vessels. Some operator shifts recorded more than 10 lockages in a single 8-hour shift. This was deemed an unrealistically high number based on discussions with LRN operations personnel.

The data from LPMS has a sharp change in yearly lockage numbers between 1989 and 1999 and 2000 to the present. Discussions with the USACE Institute for Water Resources revealed that a significant database structure change in 2000 makes knowing if vessels or lockages were

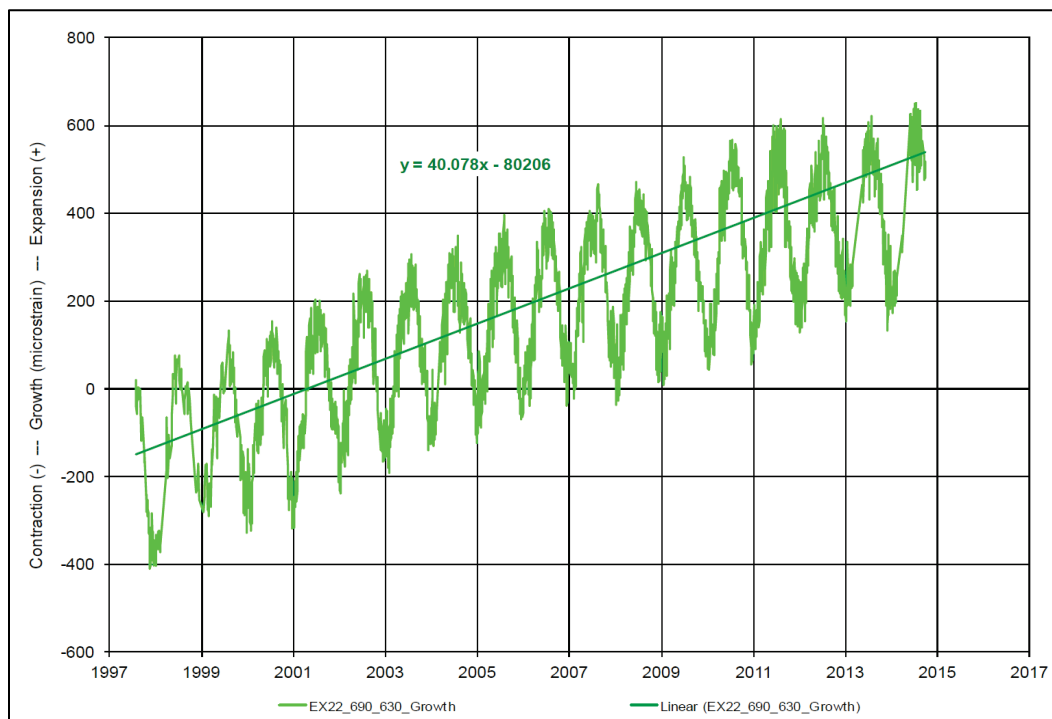
Table 1 provides a summary of the growthmeter and extensometer measurements. Vertical displacement measurements made at Monoliths 22 and 37 (located on the north and south sides of the upstream miter gate, respectively) are shown in Figure 11 and Figure 12, respectively. Linear growth is observed at both locations with an accumulation of approximately 600 microstrain ($\mu\epsilon$) over the course of 18 years of monitoring. Expansion data were available for review between 1982 and 2008 in addition to earlier survey measurements and historical information. The expansion was nearly linear and was fit to a concrete growth model to extrapolate expansion back to construction.

Figure 11. Vertical growth - Block 22 (from HATCH [2015a], Figure 4-7).

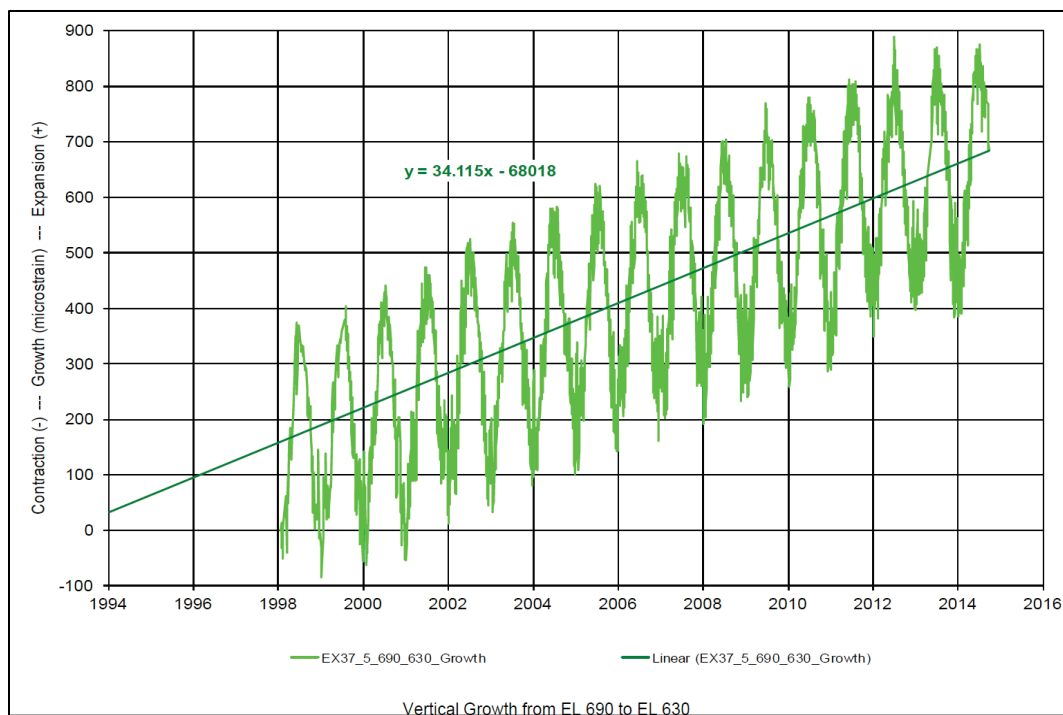
Figure 12. Vertical growth - Block 37 (from HATCH [2015a], Figure 4-11).

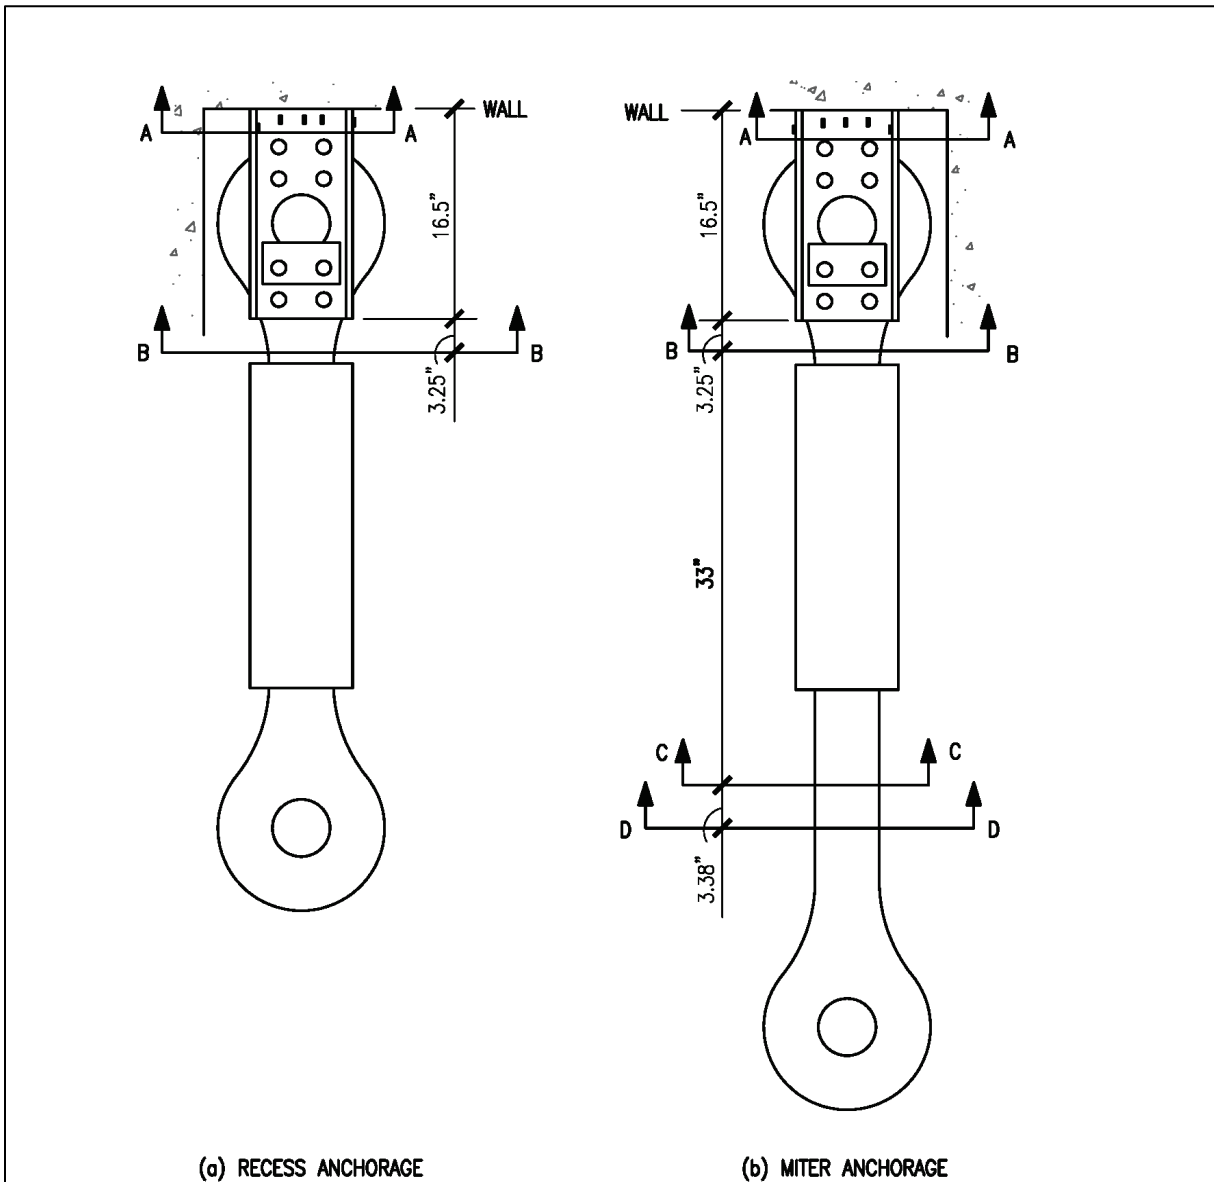
The gage locations on the channels were chosen to provide an indication of the strain distribution across the top channel. The bottom channel was generally inaccessible, so only a single gage could be placed on a channel flange. The gages on the rectangular portion of the miter anchor linkage were placed to provide a robust measurement of the axial force and bending moment in the linkage. There was no similar segment on the recess linkage, so gages were placed on the cylindrical segments of the linkage for both miter and recess to provide a way to measure axial force and bending moment in the recess linkage by calibrating those gages to the forces indicated by the rectangular gages. This process is described in detail in Chapter 3.

Figure 13. Landside anchorage instrumentation plan view.

where l is the distance between cross section C-C (location of M_1) and cross section D-D (location of M_2), indicated in Figure 13 and Figure 14.

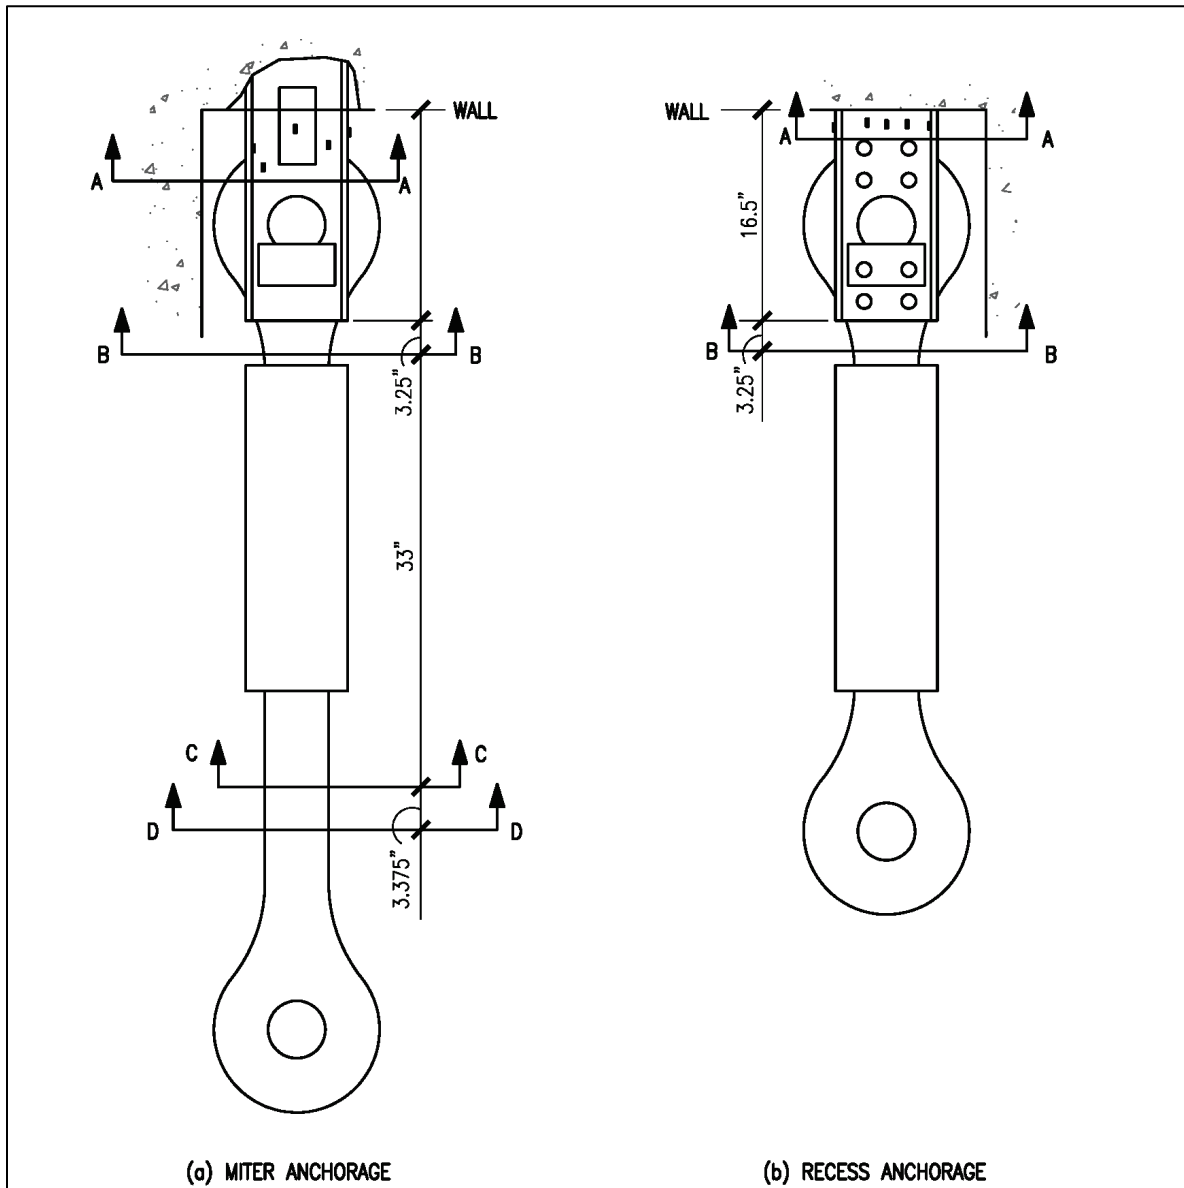
Figure 14. Riverside anchorage instrumentation plan view.

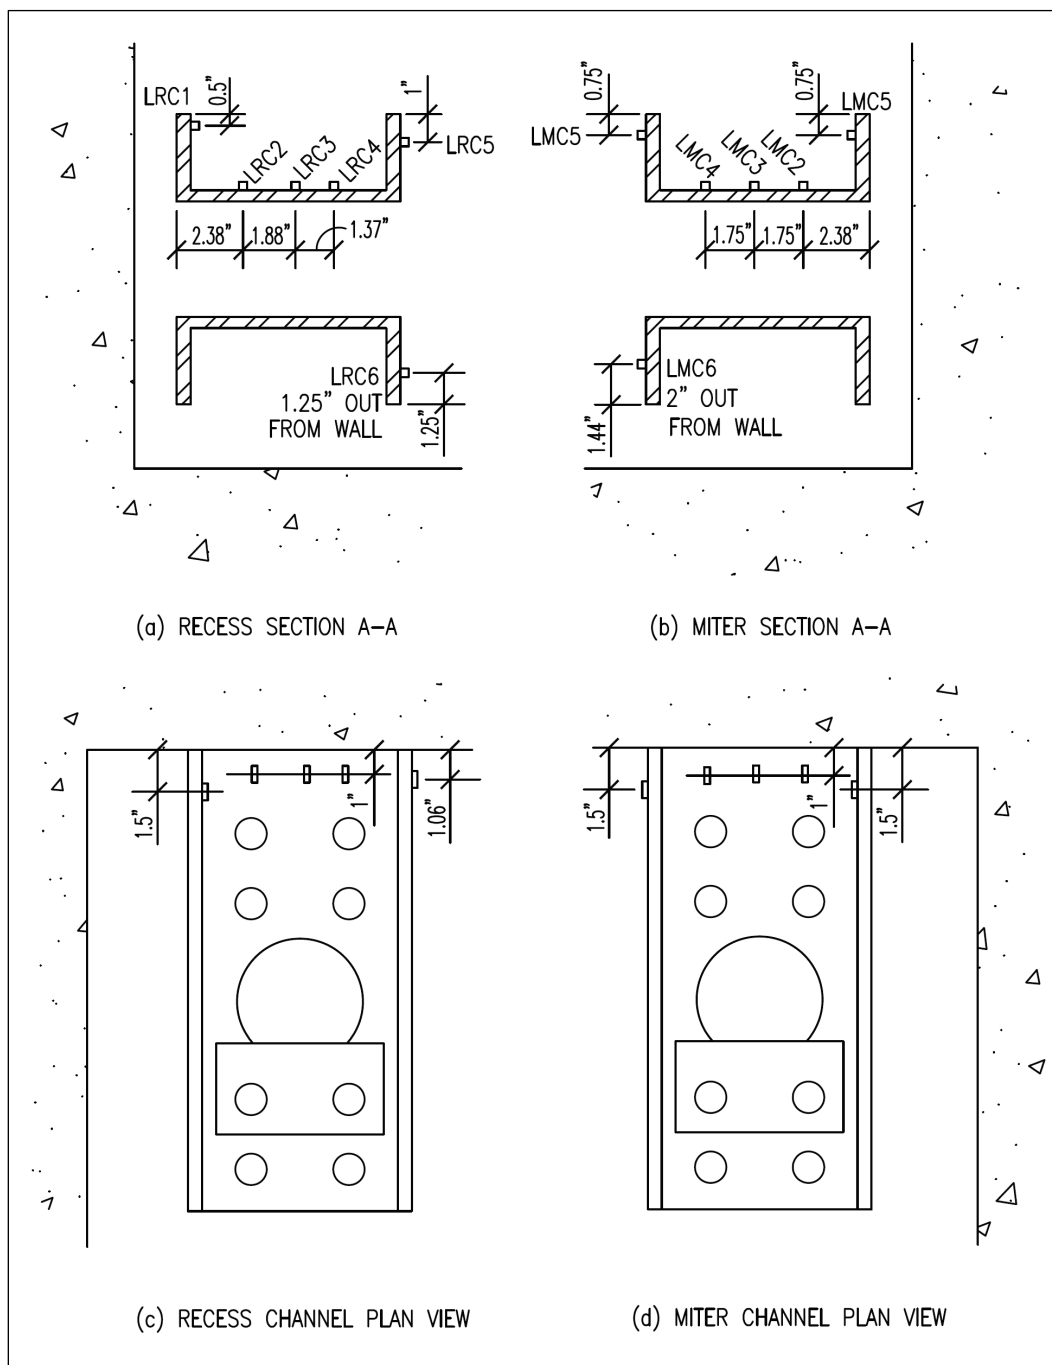
Figure 15. Landside anchor channel instrumentation detail.

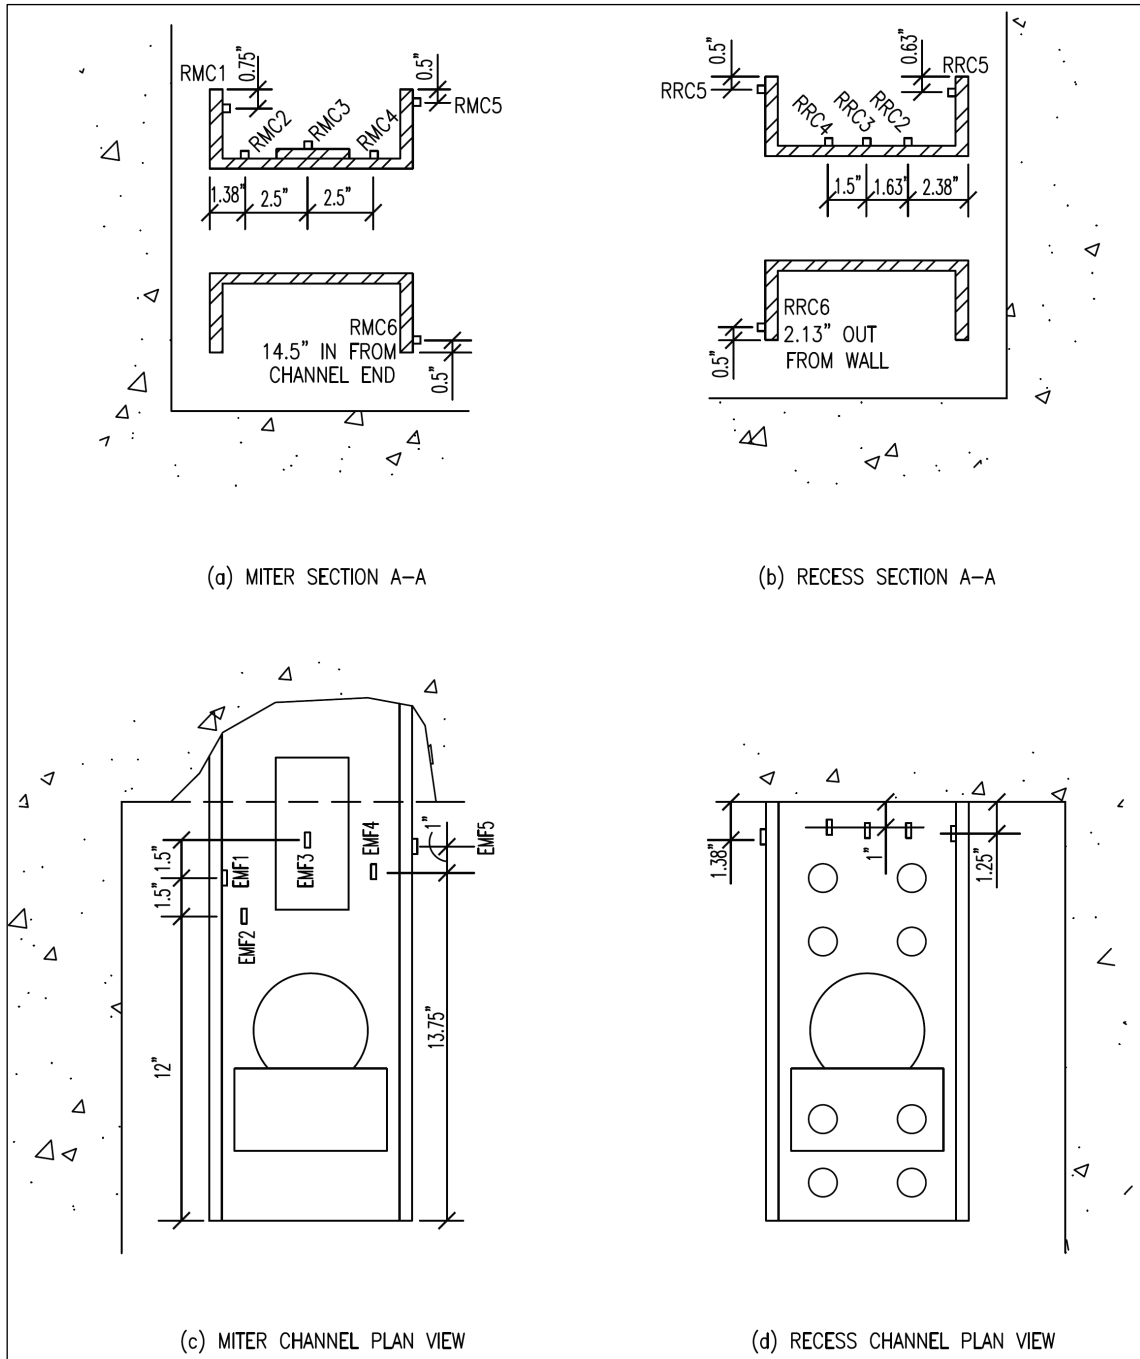
Figure 16. Riverside anchor channel instrumentation detail.

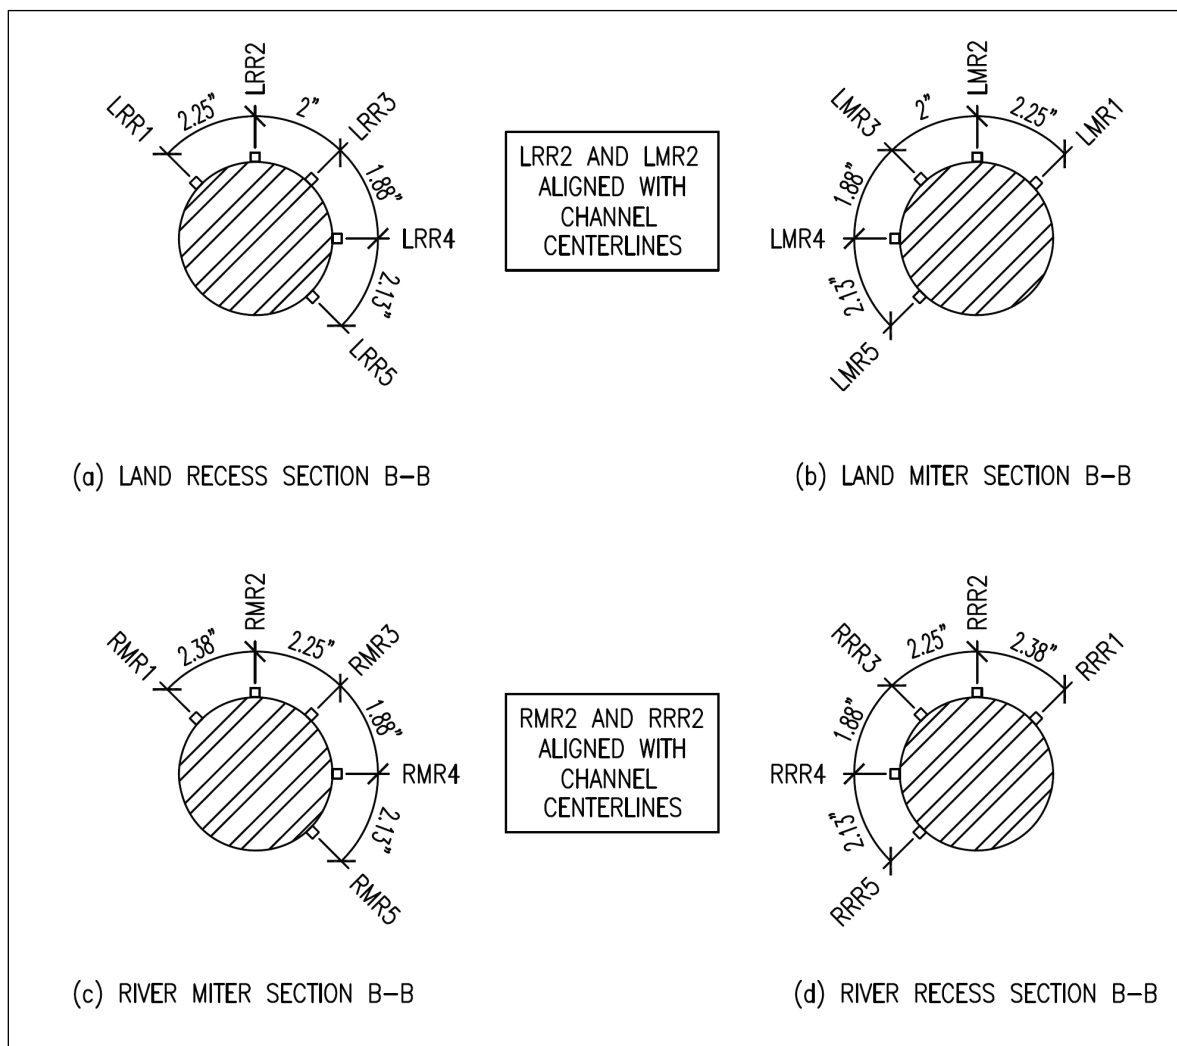
Figure 17. Circular segment anchorage instrumentation details.

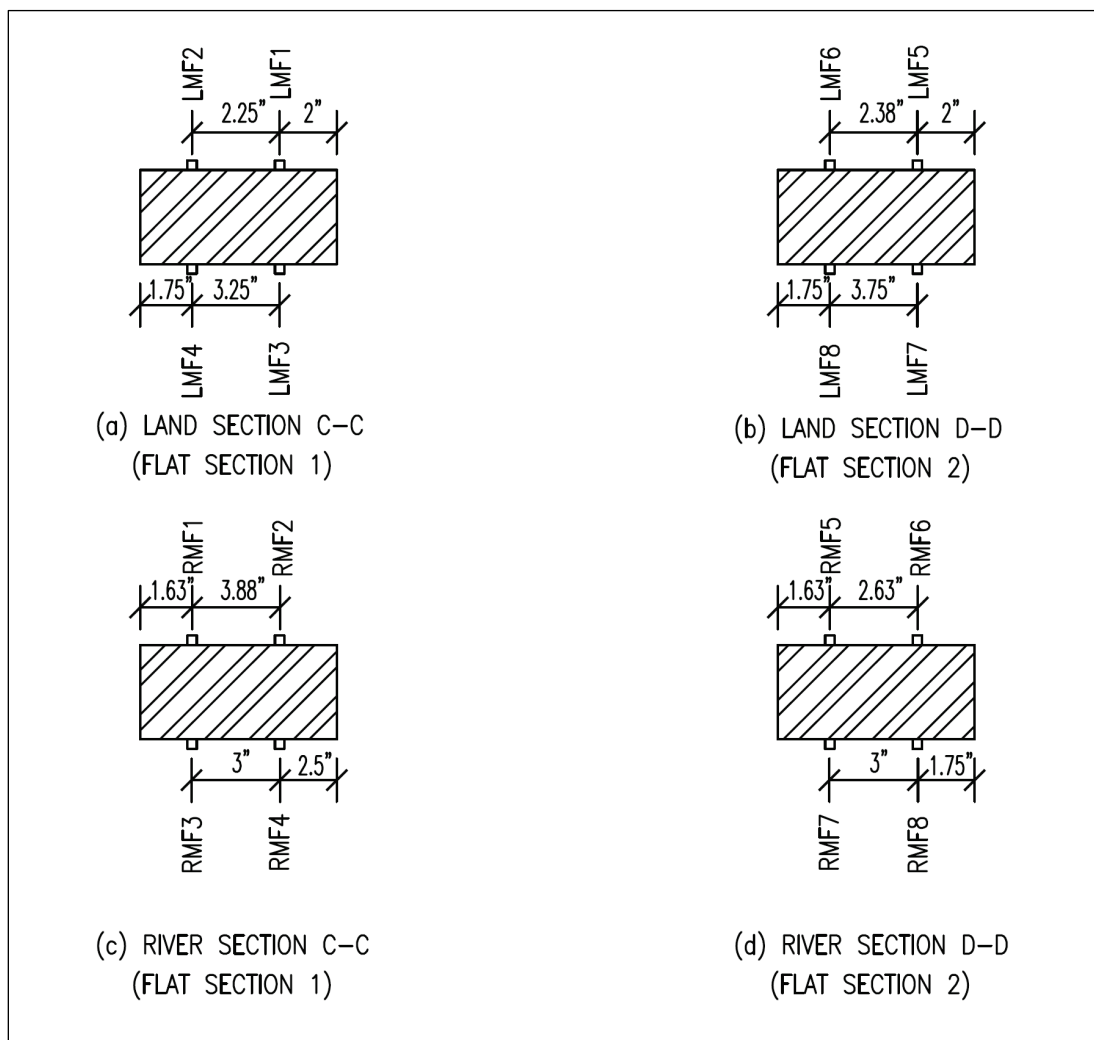
Figure 18. Rectangular segment anchorage instrumentation details.
